From: Emery, Sarah [Sarah.Emery@iberdrolaren.com]
Sent: Monday, December 27, 2010 4:07 PM
To: Lein, Jerry R.
Cc: Emery, Sarah; Powers, Keith; Seck, Timothy; Dewitz, Neal; Pickle, Joyce E.; Bartunek, Tina
Subject: PU-05-305 - Rugby Wind Farm - Tree Memo - year 1
Attachments: RugbyTreeSurveyFinal_2010.pdf

To: Sarah Emery Iberdrola Renewables 701 4th Avenue South, Suite 1010 Minneapolis, MN 55415	
From: Bruce Moreira, Joyce Pickle	Project: Rugby Wind Project
CC: Keith Powers, Iberdrola Renewables, 201 King of Prussia Road, Suite 500, Radnor, PA 19087	
Date: November 30, 2010	Job No: 87220

RE: Tree Survey for Rugby Wind Project, Pierce County, North Dakota

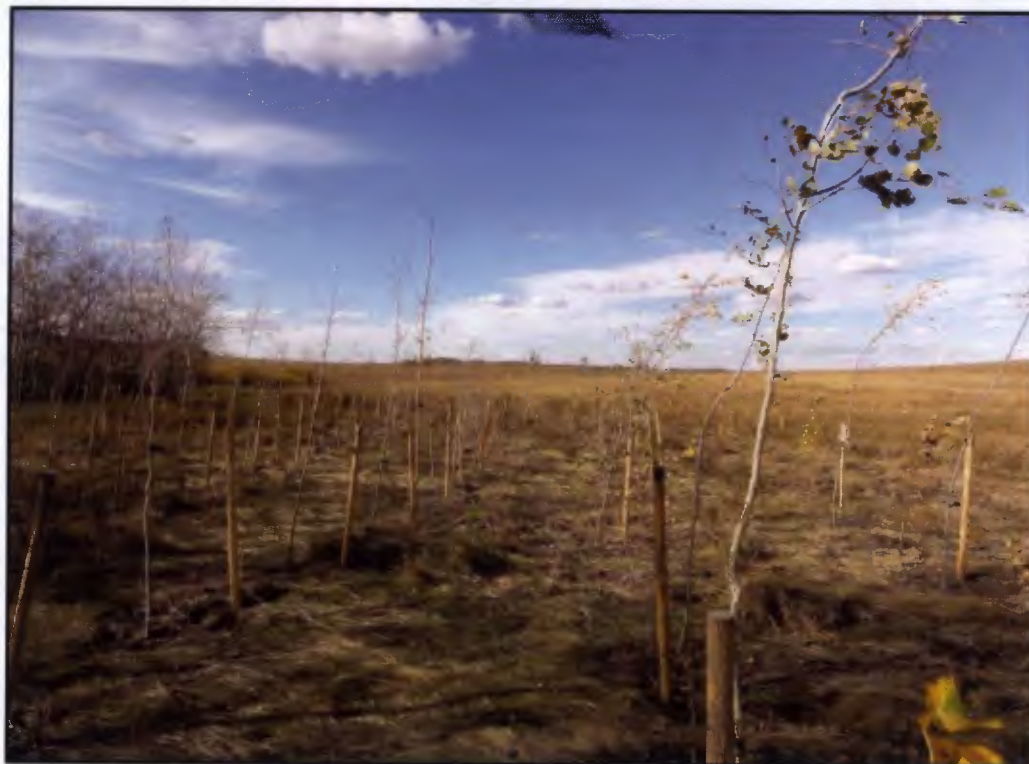
Photos 3 & 4: Aspen Trees on Gronvold Property
2010 Tree Planting Memo
Rugby Wind Project, Pierce County, ND

October planting

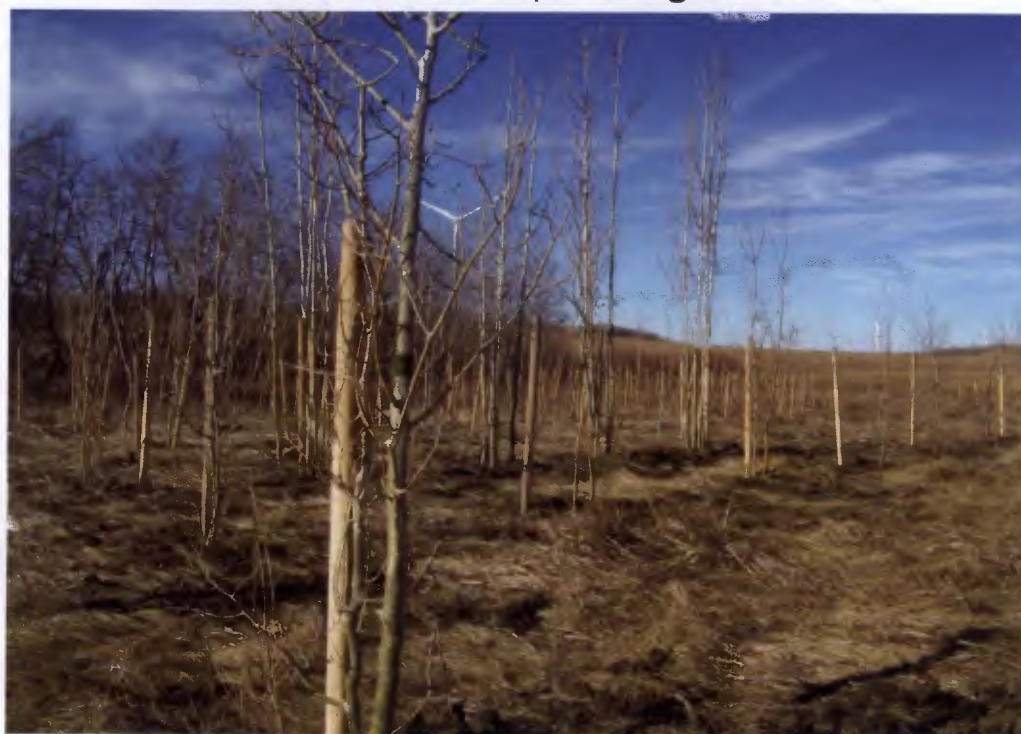
November planting

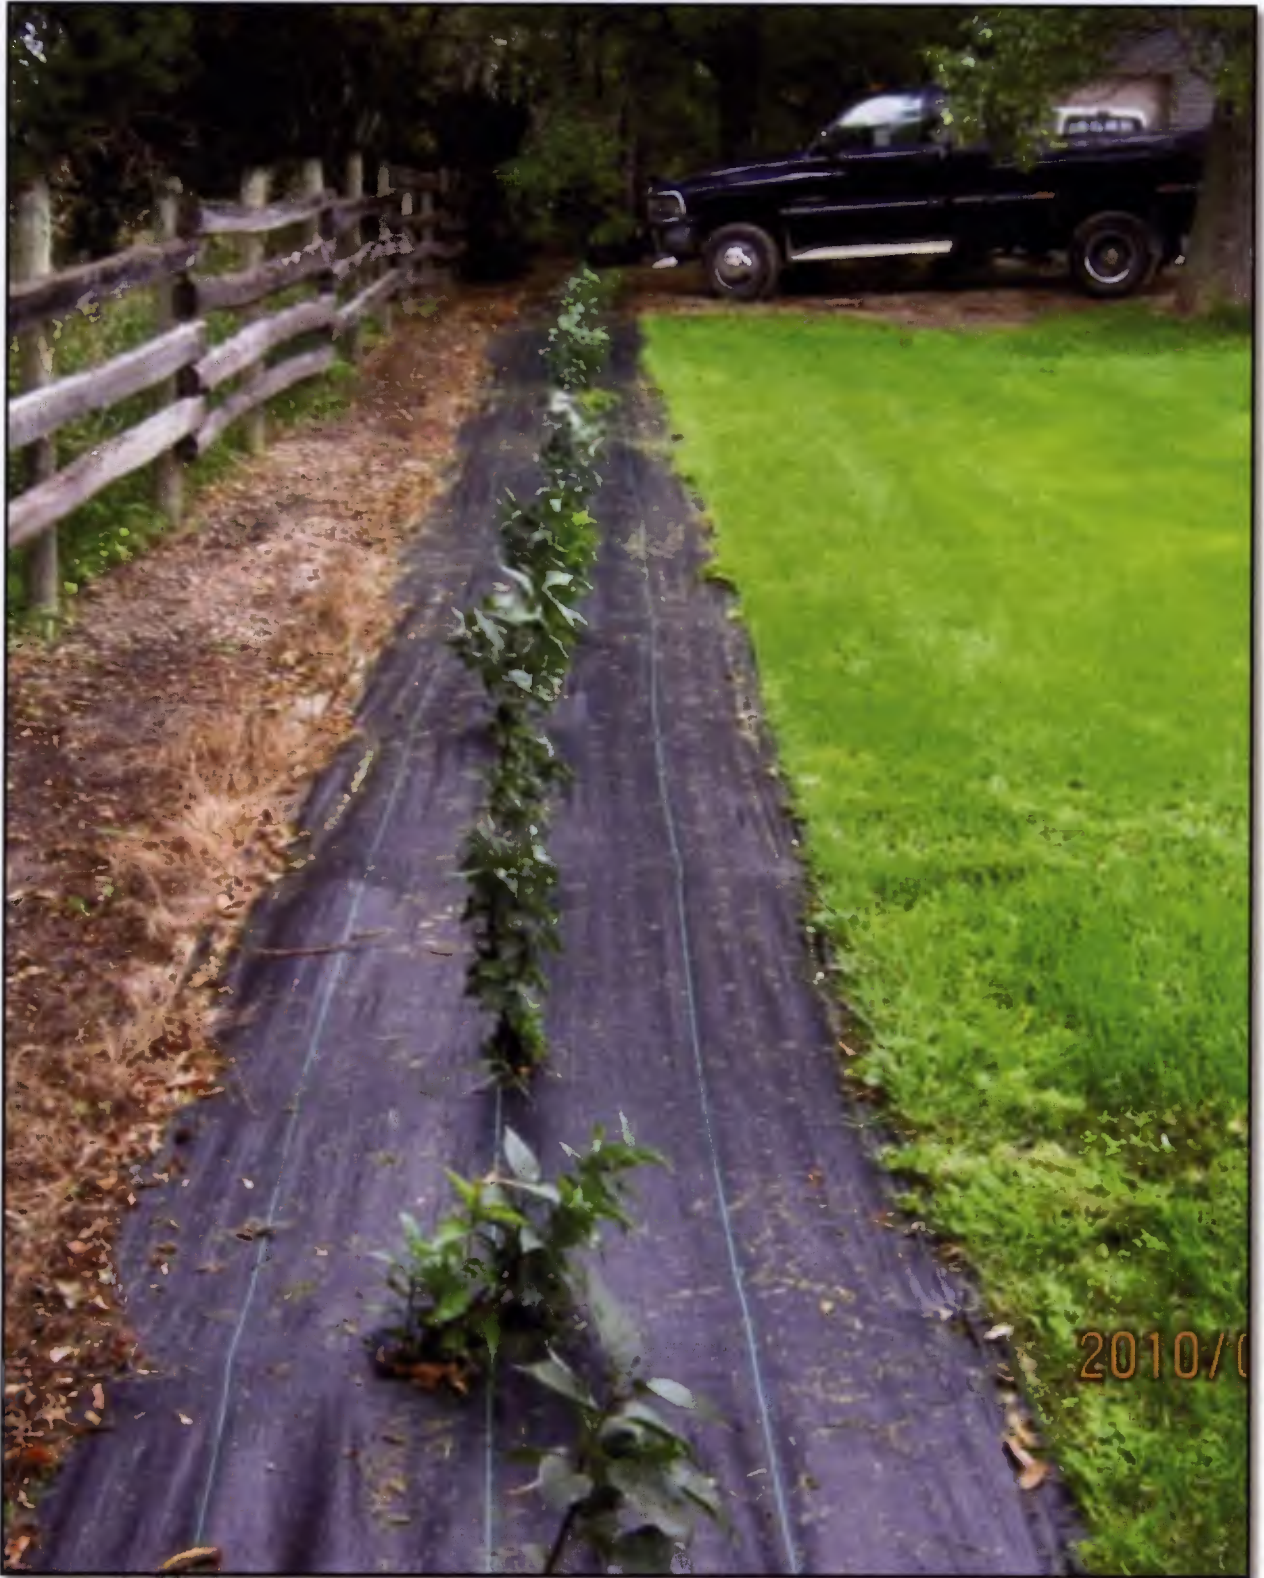
Photo 6: Lilac Trees on Kukla Property
2010 Tree Planting Memo
Rugby Wind Project, Pierce County, ND

At the time of this memorandum, up to 20 trees on the Kukla property (Area F) remain to be planted. HDR understands that the landowner prefers that 15 Ponderosa pine and 5 golden willow be planted at this location. The final planting will occur as soon as possible in the 2011 growing season.

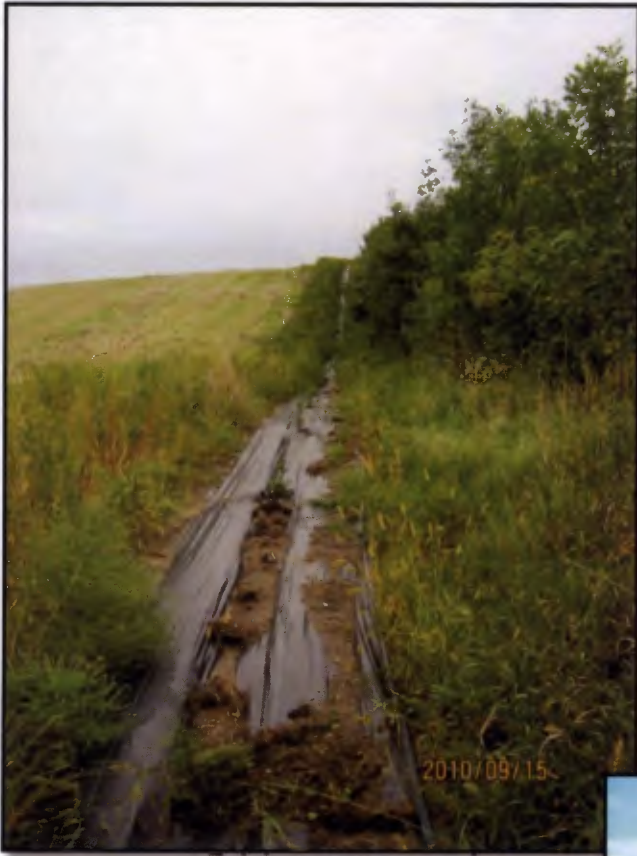
Photos 7 & 8: Colorado Blue Spruce on Kraft Property
2010 Tree Planting Memo
Rugby Wind Project, Pierce County, ND

October Planting

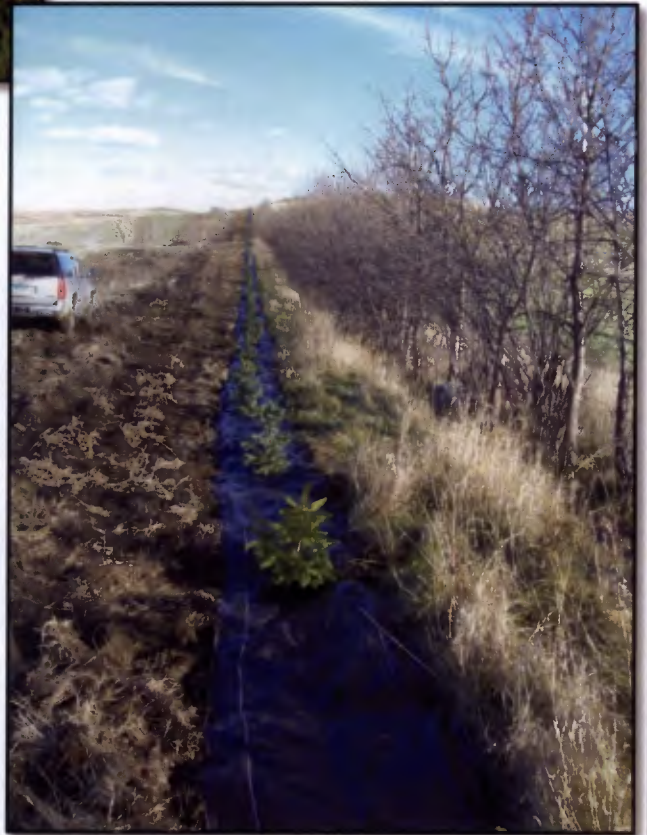
November Planting
